## Cyclic oxidation-induced cracking of platinum-modified nickel-aluminide coatings

Sebastien Dryepondt and David R. Clarke\*

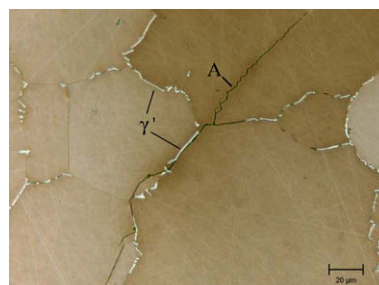
**Figure 2.** Top view of a crack in another nickel-aluminide coating, again after polishing away the thermally grown oxide. Specimen was cycled 40 times between 1150 and 1050 °C with 10 min at each temperature. Optical micrograph.

the cracks and the  $\gamma'$  precipitates along the grain boundaries, but this could not be substantiated because the crack origins could not be unequivocally identified. However, it was noted that there were no cracks that were entirely intragranular. A further striking feature of many of the intragranular crack segments was their serrated appearance, as shown for instance in area A of Figure 2.
